Control Signal Delayed On Inverter Side

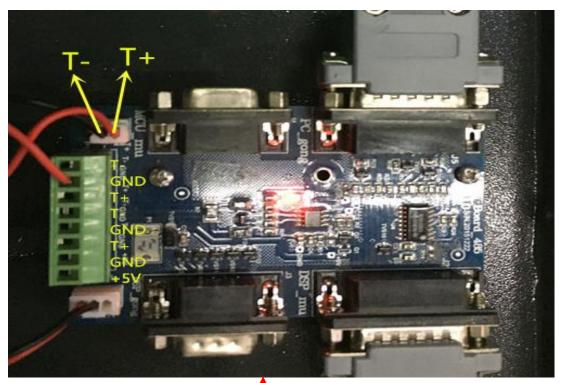
Fault description:

When trying to change working frequency of vacuum, the control signal will be delayed.

Check the voltage between T+ and T- on the 485 communication board. It should be around 2.7V~3.0V. If it isn't, 485 communication board need to be changed.

Make sure the communication cable which from electric box to PC is connected well. GND of it should be connected to system's GND.
